Pentium[®] II Processor Specification Update

Release Date: August 1998

Order Number: 243337-017

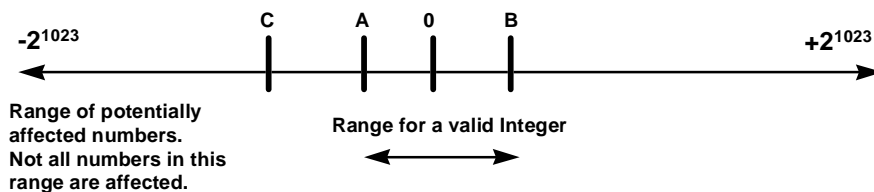
IMPLICATION: Erroneous operation results when the operand is so large that it will not fit into the target data size. The operands affected by this erratum are significantly outside (by a factor of 3X) the range that can be, correctly, converted to an integer value. The figure below and corresponding table identifies the normal range of integer numbers (between A and B) and the starting point of the operands affected by this erratum. Discrete failing operands will be present in the range between point C and the maximum negative number that can be represented by the processor (-2^{1023} in double precision format). Note 2 below gives a qualitative description of the nature of the discrete failing values. Software that does not rely on the Invalid Operation exception flag being set and signaled by either an exception OR by software polling is not impacted by this erratum.

16-bit Operation	A	B	C
	-32,768.0	+32,767.0	< -98304.0
32-bit Operation	A	B	C
	-2,147,483,648.0	+2,147,483,647.0	< -6,442,450,944.0

WORKAROUND: Any of two software workarounds will avoid occurrence of this erratum:

1. Range checking performed prior to execution of the FIST[P] instruction will prevent the overflow condition from occurring, and may already be implemented as a standard coding style.
2. Software can use the presence of MAXNEG in the result integer to indicate that an out of range conversion may have occurred.

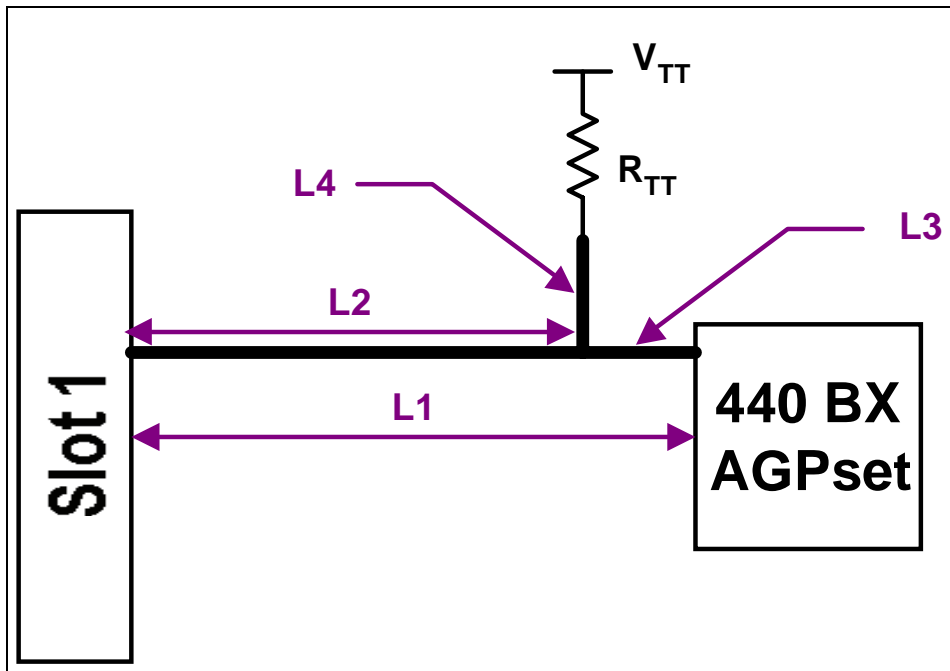
Figure 1. UP Dual Ended Termination (DET)

For UP-DET topologies (see Figure 1), the trace length L1 must be between 1.5" to 4.5" while using a 56Ω termination resistor.

WORKAROUND: If the chipset and third party agents used with the Pentium II processor do not optimize their arbitration latency as described above, no action is required. For the 66 MHz Pentium II processor, no action is required. If agents that have implemented this optimization, by following the *100 MHz GTL+ Layout Guidelines for the Pentium® II Processor and Intel 440BX AGPset* for UP-SET (single-ended termination) and DP with both processors installed, no action is required. The following two cases are additional guidelines for UP-DET (dual-ended termination) and DP-DET with only one processor populated.

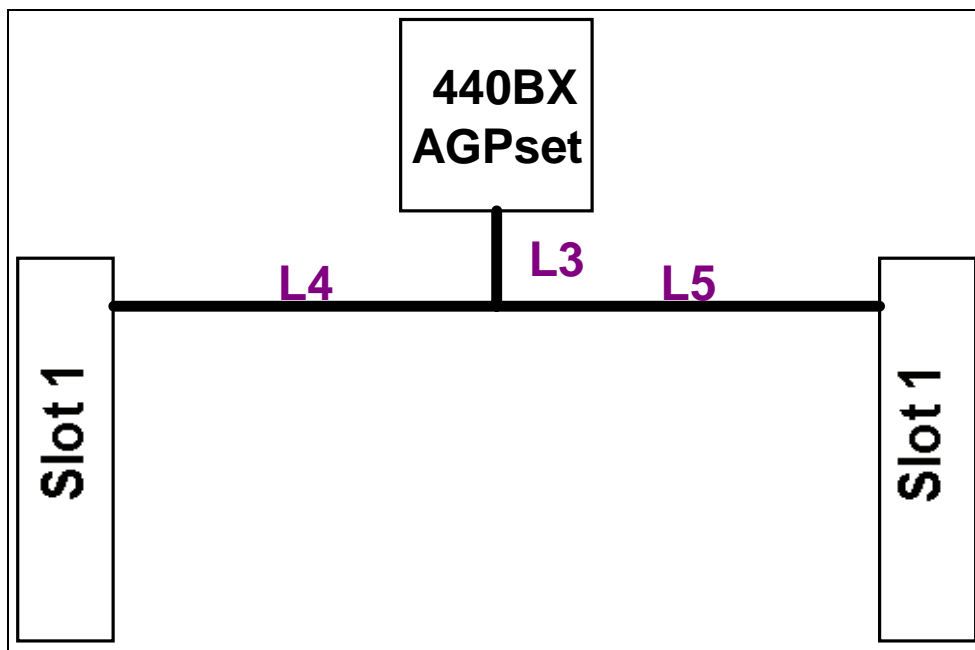
Figure 2. DP Dual Ended Termination (DET)

For DP topologies (see Figure 2) installed with a processor and a termination card, L4 + L3 or L5 + L3 must be less than or equal to 4.5". Additionally, for DP platforms with one processor installed, the termination card should be placed in the longer leg.
